**ACTIVE CRACK CONTROL FOR CONTINUOUSLY REINFORCED CONCRETE
PAVEMENTS IN BELGIUM THROUGH PARTIAL SURFACE NOTCHES**

Submitted for consideration of presentation and publication at the
2014 Annual Meeting of the Transportation Research Board

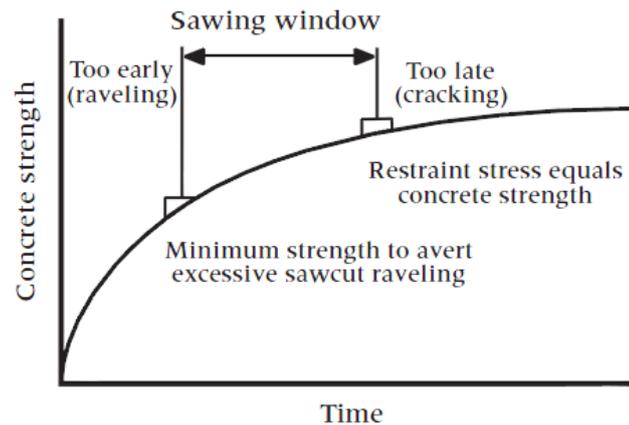
FIGURE 1 Concept of joint sawing “window” (Okamoto et al.1994).

Timing is a very important factor in achieving the goal of crack induction, particularly at shallow saw cut notches. There is an ideal “saw-cutting window”, as show in Figure 1. If the timing of the saw cutting operation is too early, raveling of the concrete will occur because the concrete has not yet developed enough strength to resist the saw machine. On the other hand, a too late saw cutting operation which may result in random cracking due to the buildup of residual stresses (16). The later time limit is of particular concern because the longer that sawing is delayed, the greater the chance that random cracking may develop (17).

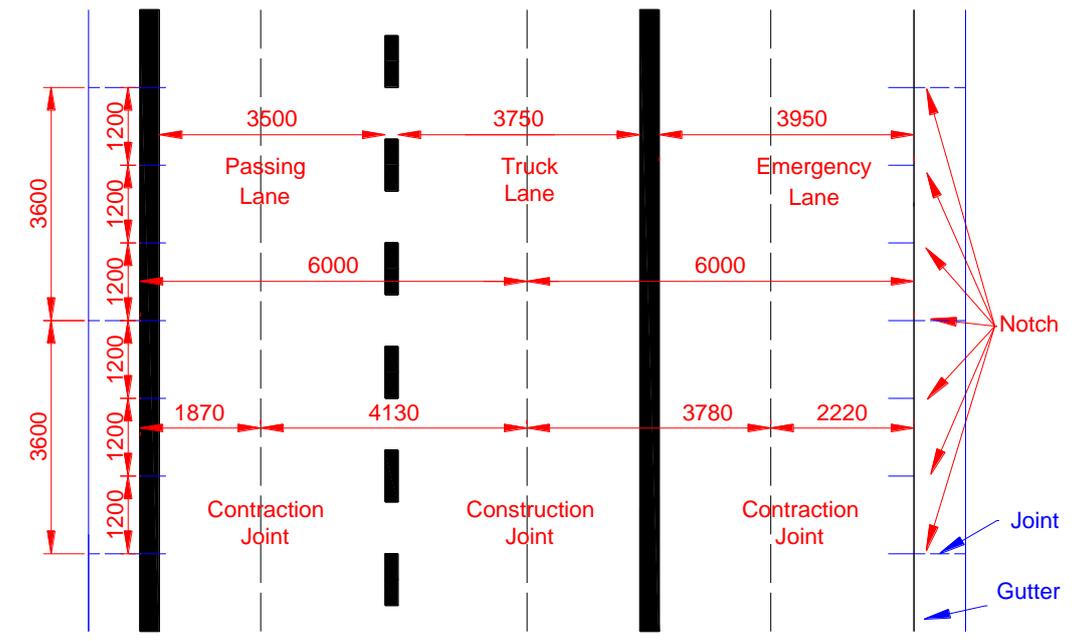
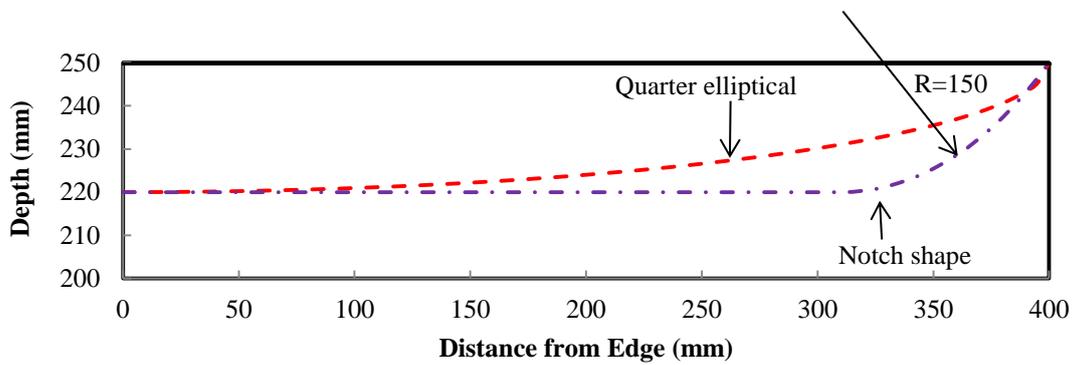
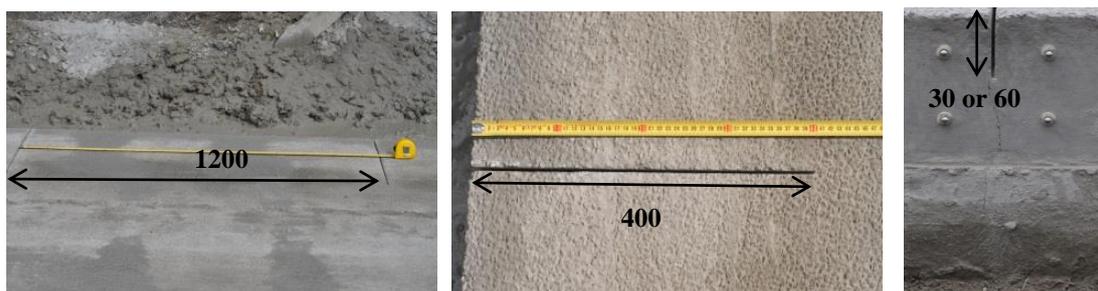
FIGURE 2 Schematic view of active crack control test section in E313 (a) plan layout of applied notches, joints and lanes; (b) notch face; (c) notch interval, notch length on the pavement surface, and notch depth.

The reconstruction project E313 between Antwerp and Herentals was conducted in 2012. Figure 2 shows the layout of the test sections in E313, which was constructed according to the current standard practice in Belgium: 250 mm thick CRCP slab laid on a 50 mm bituminous inter-layer and a lean concrete base. The longitudinal reinforcing steel amounts 0.75%, and the position of the longitudinal steel reinforcement is about 80 mm below the pavement surface. Besides, due to the noise reduction requirement and economic considerations, two-lift construction was adopted for the concrete slab layer, the thickness of the top and the bottom layer is 50 mm and 200 mm, respectively.

As shown in figure 2 (c), during the hardening of concrete partial surface notches were sawn on the outer side of the constructed slab, the length of the saw cut is 400 mm, and the spacing is 1.20 m. The cut was applied immediately after the washing out of the surface of the pavement, generally within 16 hours after concrete placement. Regarding the face of the notches, the end of the notch would not have a flat face but a curved face as the saw blade is circular as illustrated in figure 2(b).

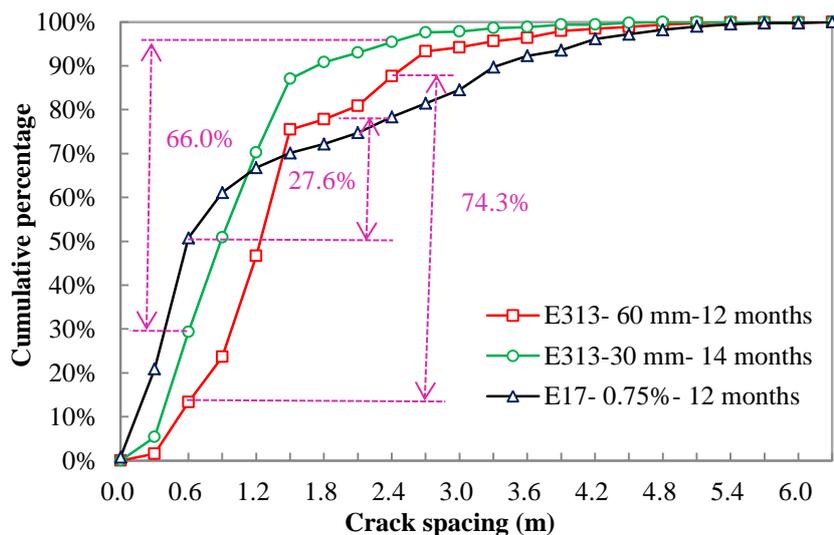
FIGURE 3 Comparison of cumulative crack spacing distribution.

Figure 3 compares the cumulative crack spacing distribution between non-active and active crack control sections. Comparisons show that the saw-cut section on the E313 has a much better crack spacing distribution, as illustrated in figure 3. The 60 mm notch section has less than 13.3% cracks spaced less than 0.6 m (short spaced cracks) approximately 12 months after paving. Besides, more than 74.3% of the crack spacing falls into the desirable range, 0.6 m to 2.4 m. In contrast, the non-active crack control section in E17 has about 50% of the cracks less than 0.6 m and only 27.6 % of cracks within the ideal range at the same age which is considered as an undesirable crack spacing distribution. Among the active crack control sections, the deeper the saw cut, the much more expected crack spacing distribution.

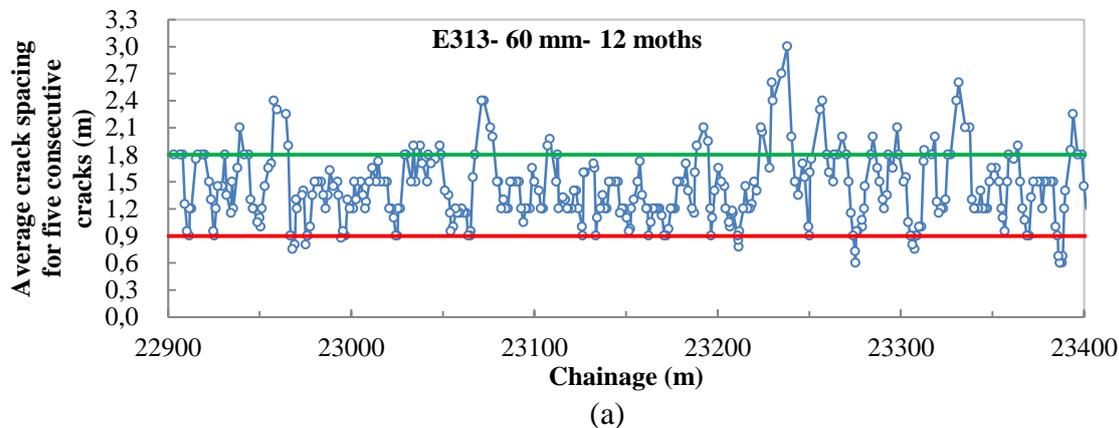
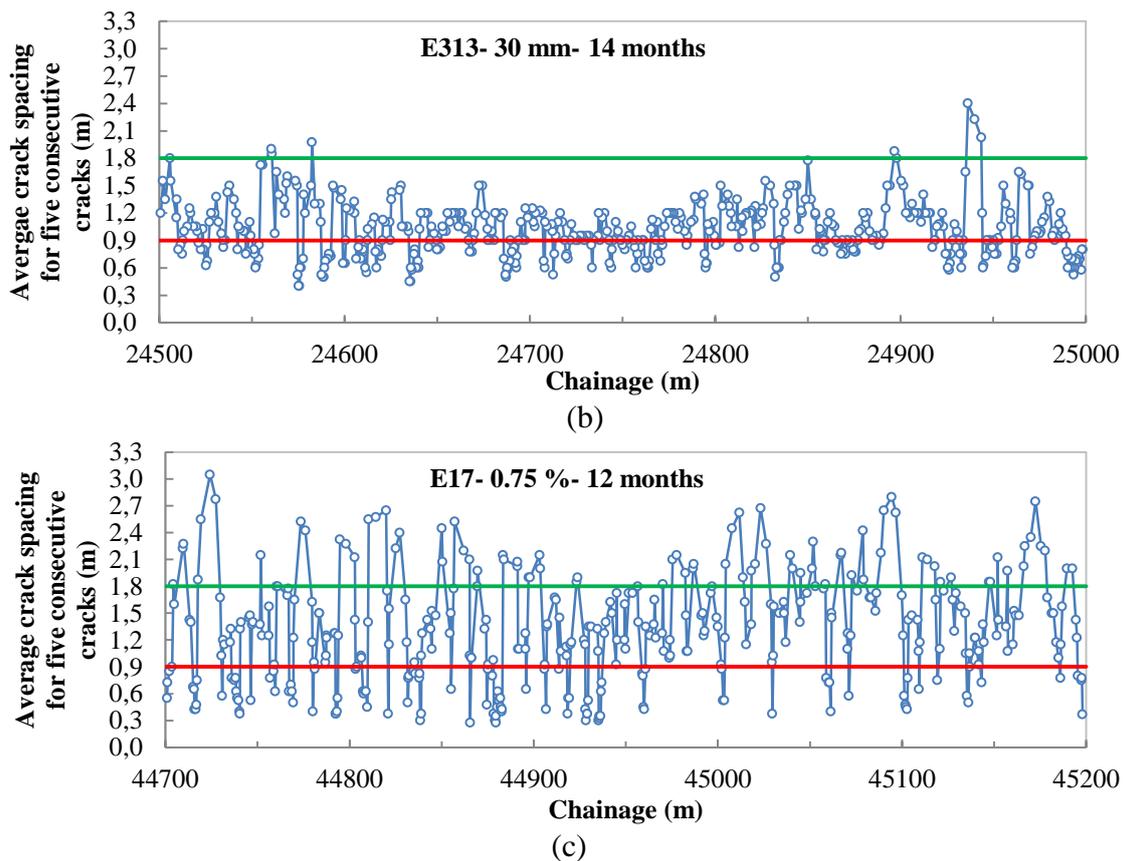
FIGURE 4 Average crack spacing distribution based on five consecutive cracks (a) E313, 60 mm deep saw cut; (b) E313, 30 mm deep saw cut; (c) E17, De Pinte, 0.75%.

The uniformity of the crack spacing can also be indicated by the average spacing of five moving consecutive cracks. The average spacing of five moving consecutive cracks is not only useful in identifying the locations of clustered cracks (group of cracks with average cracks spacing less than 0.6 m) but also can be used to identify the extent of a pavement section that exhibits “acceptable” crack pattern (6, 10). The acceptable values of the average spacing of five moving consecutive cracks are assumed to be between 0.9 and 1.8 m. Figure 4 presents the comparison of average spacing of five moving consecutive cracks on both active crack control test sections and the non-active crack control section. It is clearly shown that 60 mm saw cut section has the best ideal crack pattern than that of the 30 mm active crack control section and the non-active crack control section of E17.

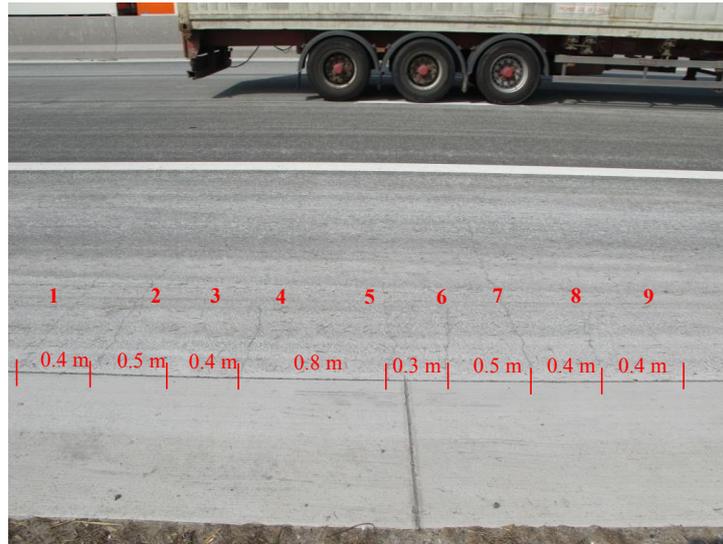
FIGURE 5 One cluster cracks in passive crack control section in E17.

One typical crack spacing feature of CRCP under the current design concept is the high percentage of clusters of closely spaced cracks (5), as shown in Figure 5. Clustered cracks typically act as an indicator for punch-out development. The probability of two, three, four or five consecutive cracks occurring within a range of distances can be chosen as an indicator to evaluate the evidence of cluster cracking within a particular pavement segment. Zollinger (1999) developed an algorithm to calculate the probability of cluster cracking as (16):

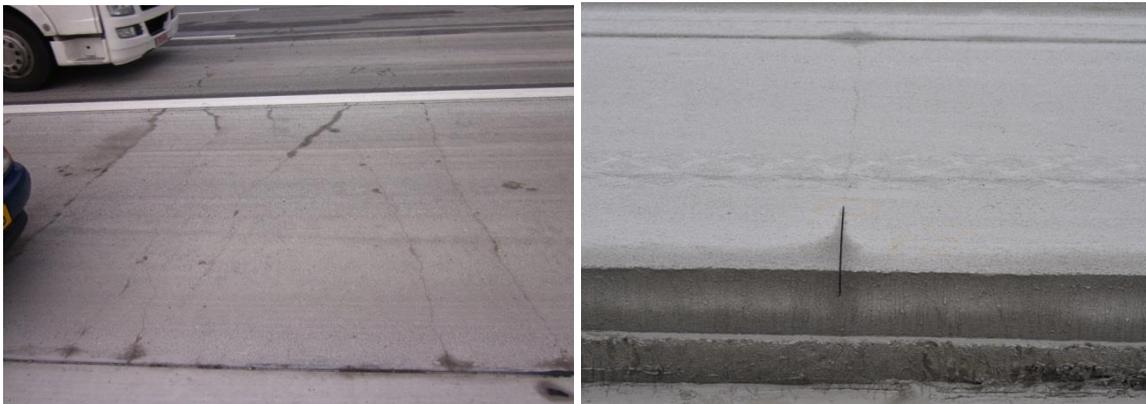
FIGURE 6 (a) Natural cracks in E17 at 2 months after construction; (b) induced crack in the 60 mm deep sawcut section in E313 of 2 days after construction.

The field surveys revealed that the non-active section in E17 exhibited a fair amount of meandering, divided and Y-cracks, as shown in Figure 6(a). In contrast, there are no above-mentioned undesirable cracks in the 60 mm deep active crack control test section during the first 4 days after construction, and the 193 occurred transverse cracks are all perfectly straight as shown in Figure 6(b). However, the subsequent field surveys indicated that both active crack control sections exhibited lightly meandering cracks and occasionally divided cracks and Y-cracks, especially in the 30 mm depth saw cut section. But field surveys also showed that the 60 mm depth saw cut section had much less meandering, divided, Y cracks and closely spaced cracks than that of 30 mm depth saw cut section. It illustrates that a deeper saw cut depth is better to achieve a good crack pattern. Because the shallow depth partial

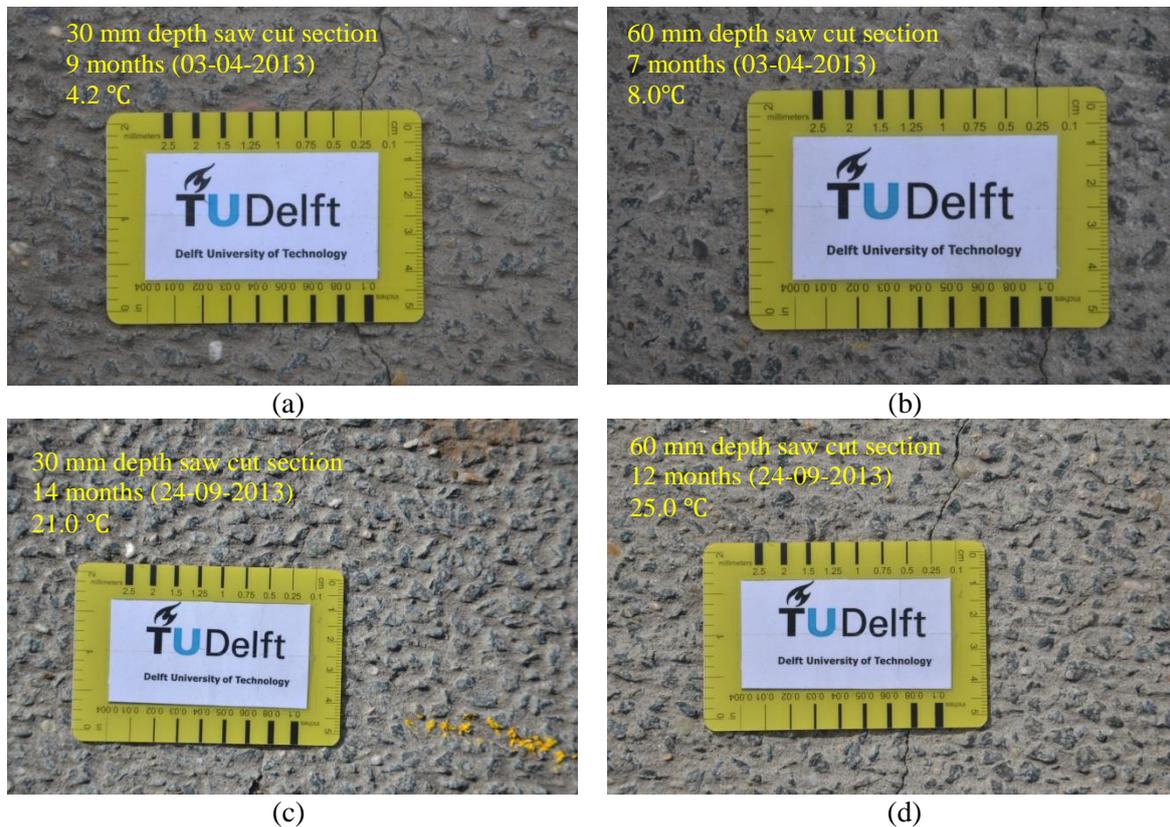
FIGURE 7 Crack width on the pavement surface of E313 (a) 30 mm section in low temperature ; (b) 60 mm section in low temperature; (c) 30 mm section in low temperature ; (d) 60 mm section in high temperature.

Crack width is a vital factor influencing the performance of CRCP. The crack width was measured inside the cracks at some depth (1 to 3 mm) below the pavement surface. Meanwhile, the concrete pavement surface temperature was also recorded. Figure 7 shows the hairline crack on the pavement surface for both active crack control sections in cold and warm temperature conditions.

Table 3 shows the crack width periodically measured by a microscope on the pavement surface. The measured average crack width on the pavement surface of E313 was approximately 0.15 mm at an average pavement temperature of 20 °C, and around 0.22 mm at an average pavement temperature of 6.0°C. The crack width on the passive crack control section of E17 is on average slightly larger than that of E313. The cracks on the surface meet with the crack width limitation of CRCP in Europe, 0.40 mm. In addition, in order to obtain the horizontal crack width variation due to temperature variation, a procedure was adopted to measure the horizontal crack width change by a linear variable differential transformer (LVDT) on steel studs glued at the edge of the pavement at either side of the crack (4-5). The daily crack movement at the pavement surface during summer condition, within 4 days after construction, varied from 0.0 to 0.15 mm.
